Bellhousing Alignment Instructions

Checking bellhousing alignment

RobbMc Offset Dowel Pins Installation Instructions

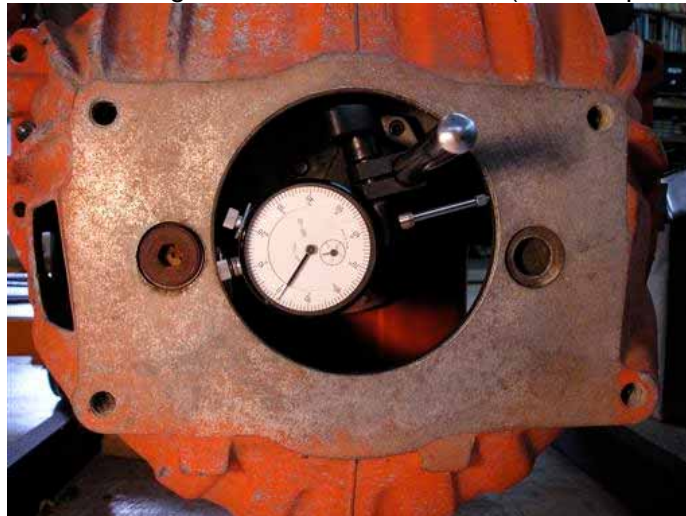
Fig. 1

2. Install magnetic dial indicator base on the flywheel/end of crankshaft and adjust the dial plunger so that it contacts the inside edge of the register bore of the bellhousing (**Fig. 1**). If you need to create space for the dial indicator base to sit flat on the flywheel, remove two of the flywheel bolts that are directly across from one another. Please note that the dial indicator base does not need to be dead-centered on the crank during this process but it must be solidly mounted. If you do not have a dial indicator, Summit Racing has an inexpensive one with a magnetic base for about \$30 (Summit part #SUM-900016-1).

8. Install bellhousing and torque bolts to specification. Re-mount the dial indicator and recheck runout by repeating step #2. Small corrections can be made by loosening the bellhousing bolts and turning the dowels with a wrench to bring the bellhousing within limits.
